SICHERHEITSMITTEILUNG **für Gurtzeuge**

Nummer: 2023-02 SM **2023-001** Paraworld – Sife - Klappe

Service Bulletin 2023-001

Subject: Zig zag stitching on main container flap #2

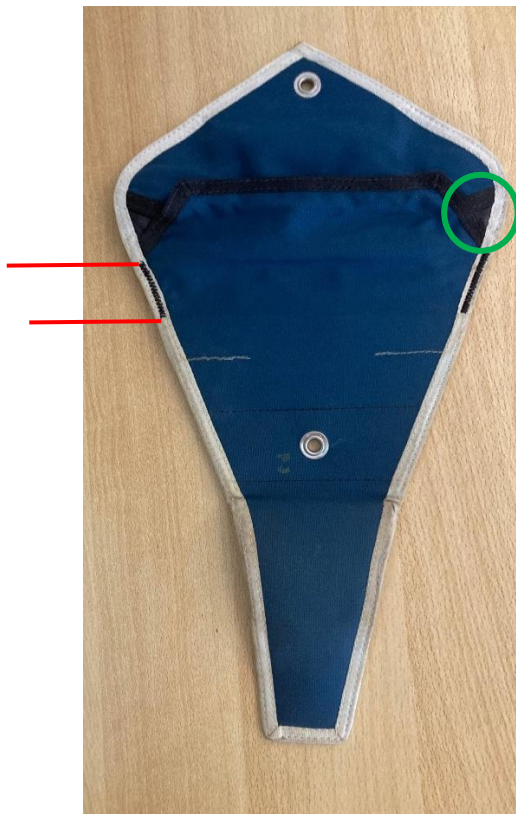
We have been informed that during the activation of the main canopy, one suspension line of the left rear suspension lines caught on the main container flap #2.

Unfortunately, we didn't have the chance to inspect the affected harness and container system to find out the concrete reason why the line was caught on the main container flap #2.

During the pack job the lines had to be laid under the reserve container as described on page 50 in our OWNER MANUAL as **WRONG** and the main canopy had to have a pulling direction which would be due to an unstable body position.

Before the next reserve repack your rigger may strengthen the main container flap #2 with a zig zag stitching as shown on the picture between the two red lines. Start at the end of the binding, where the flap is attached to the reserve container and end at the beginning of the stiffener (red lines in the picture below). Overstitch your zig zag stitching once.

Don't stitch over the two bindings (green circle in the picture below) because there are already two bar tacks under the binding. You don't have to separate the flap from the reserve container while doing the zig zag stitching.
