Initial Incident Report

02 March 2011

Drop Zone: Skydive San Marcos, Texas

Date of Skydive: Monday, 21 February 2011

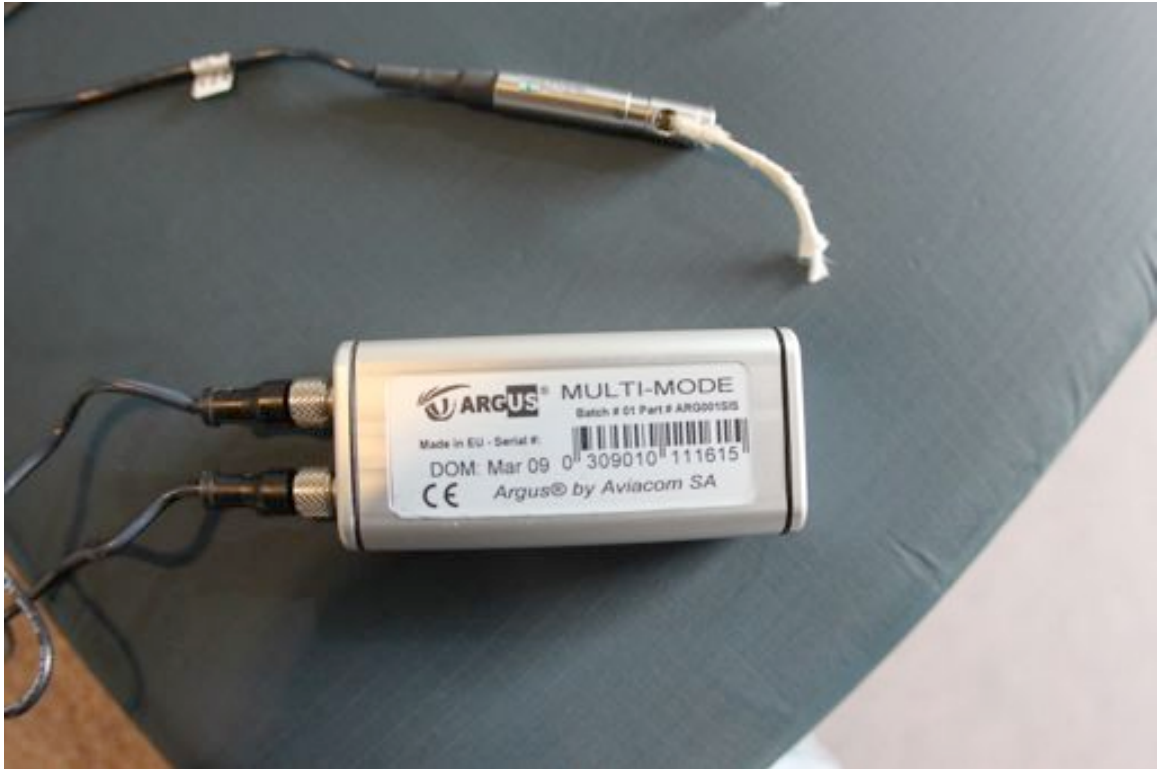
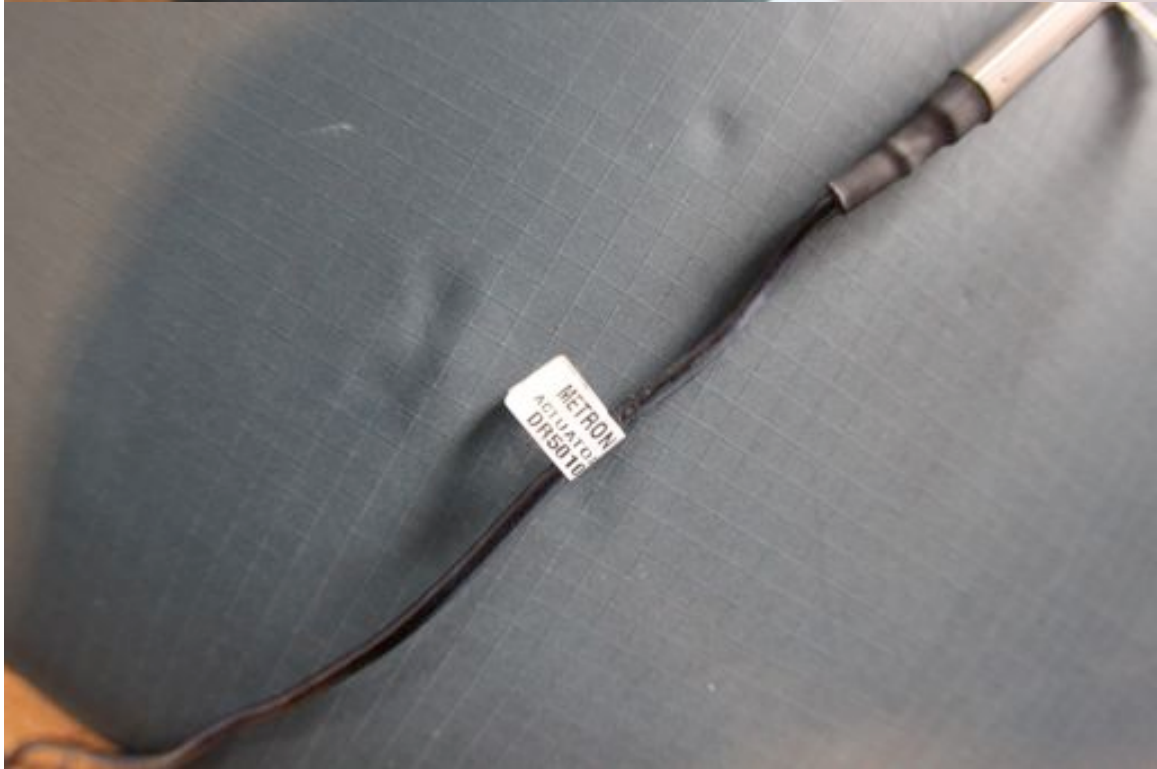
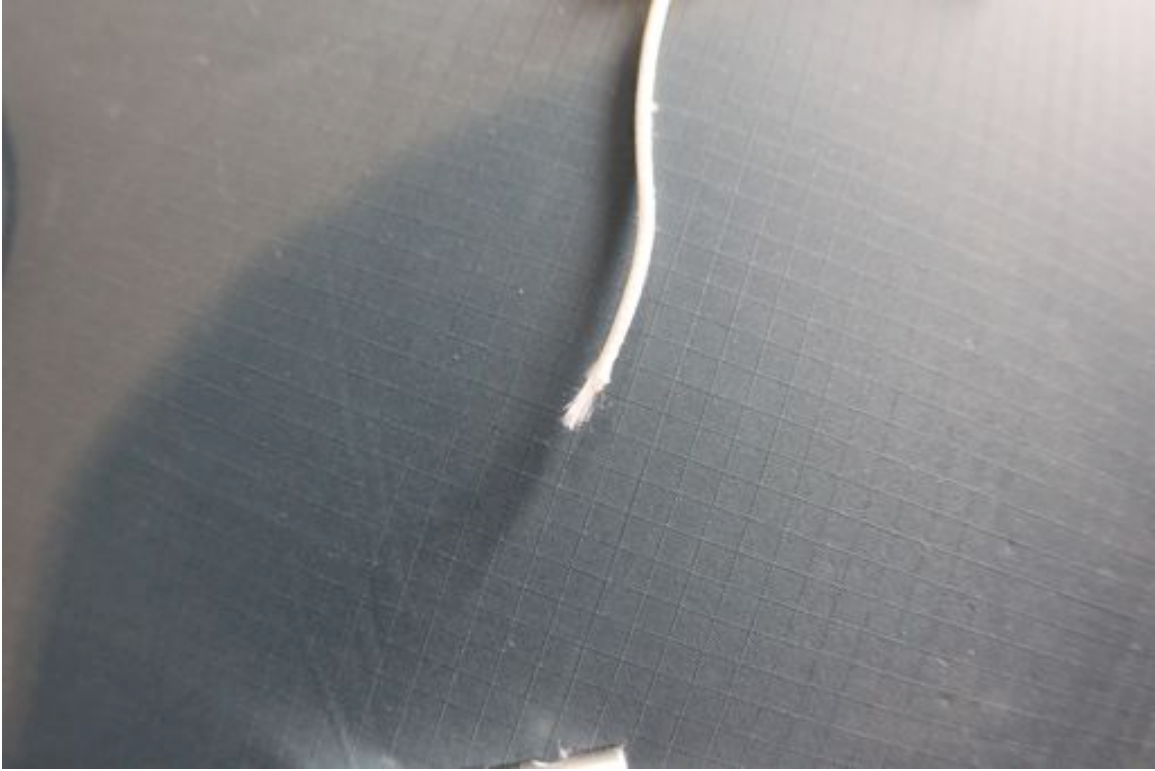
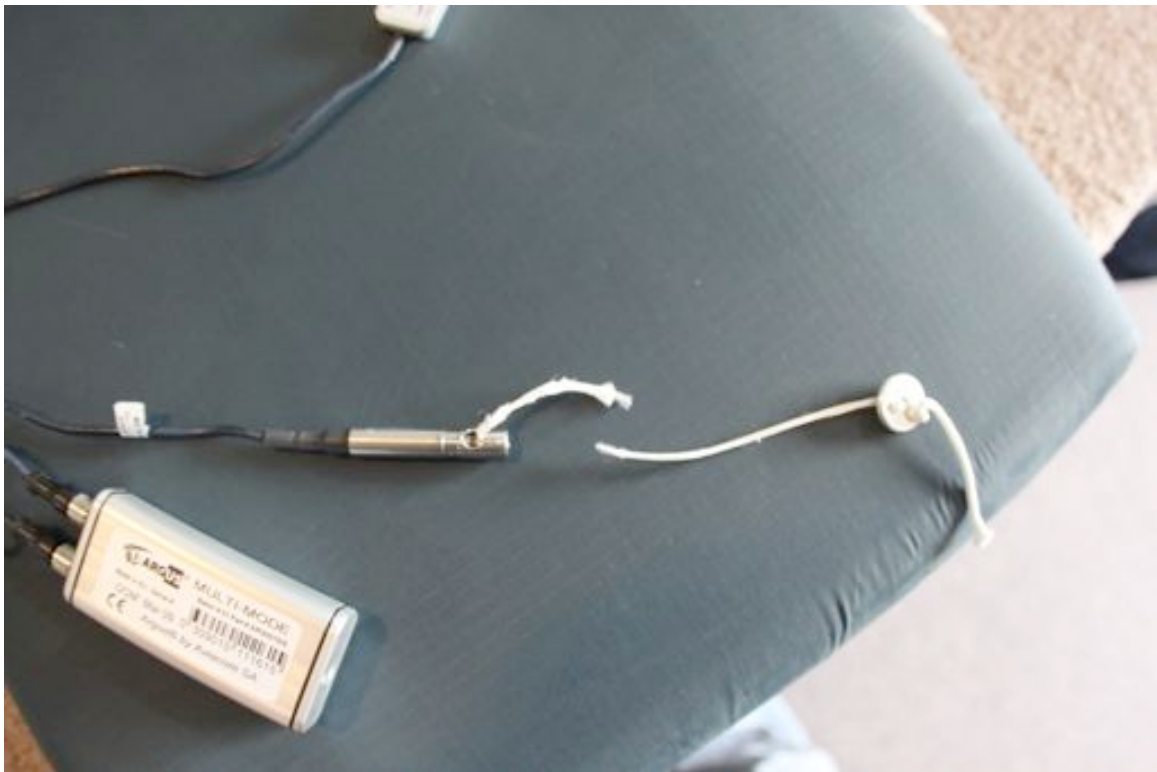
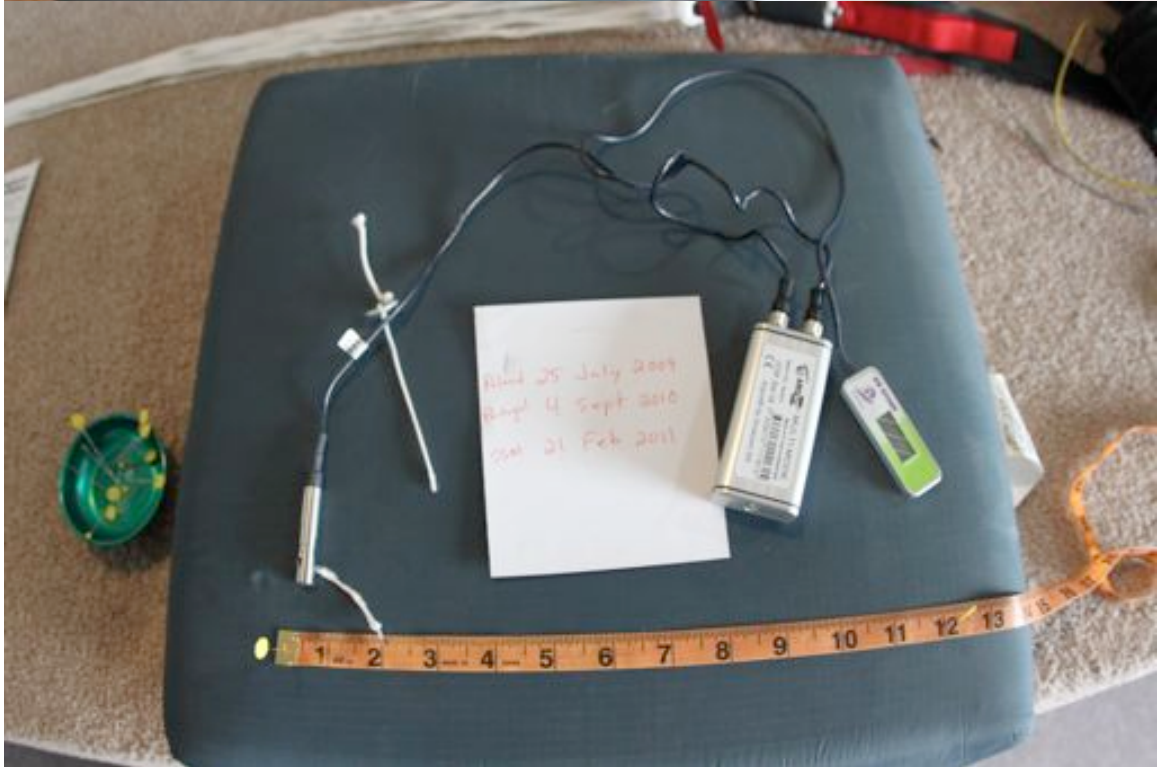
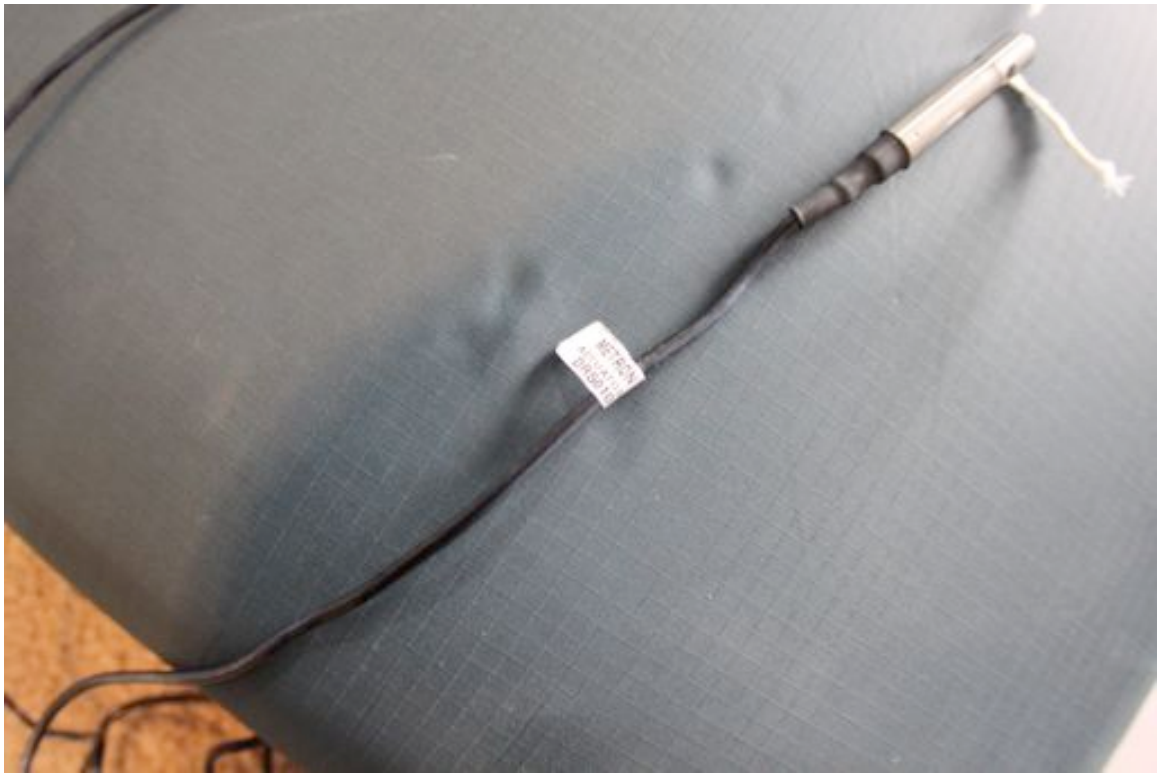
Investigation by the drop zone staff riggers, Eric Butts and Paula Wargo Hunt determined that the closing loop (recommended in the manual to be 4.5” to 4.75”) was actually approximately 4 ½” originally and not more than 5”. Loop seemed to be dry, lacking in the recommended treatment of silicon by the manufacturer. Cut ends of the loop were found to be uneven in length. All reserve grommets were absent of any burrs or sharp edges. Cutter was located on top of pilot chute. Battery voltage was ok in unit, as determined by self test.

Reserve seems to have been packed in concordance with the manufacturers recommendations except for the absence of silicon on the closing loop.

Conclusion: It is our belief that the cutter of this unit, when fired, did not cut cleanly through the closing loop, thus leaving the container closed.
