SICHERHEITSMITTEILUNG **für Gurtzeuge**

Nummer: 2023-02 SM **2023-001** Paraworld – Sife - Klappe

Service Bulletin 2023-001

Subject: Zig zag stitching on main container flap #2

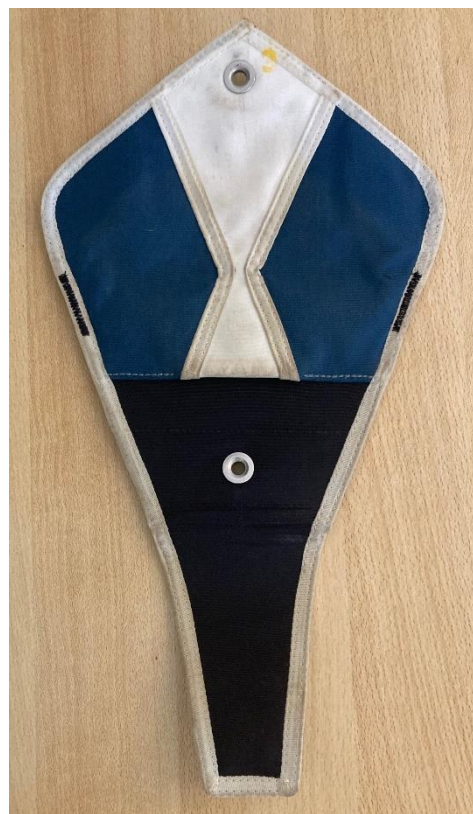
We have been informed that during the activation of the main canopy, one suspension line of the left rear suspension lines caught on the main container flap #2.

Unfortunately, we didn't have the chance to inspect the affected harness and container system to find out the concrete reason why the line was caught on the main container flap #2.

Before the next reserve repack your rigger may strengthen the main container flap #2 with a zig zag stitching as shown on the picture between the two red lines. Start at the end of the binding, where the flap is attached to the reserve container and end at the beginning of the stiffener (red lines in the picture below). Overstitch your zig zag stitching once.

Don't stitch over the two bindings (green circle in the picture below) because there are already two bar tacks under the binding. You don't have to separate the flap from the reserve container while doing the zig zag stitching.
