## PRODUCT INFORMATION BULLETIN

**Bulletin Number** : PIB-01-2026

**Subject** : Vigil Cutter Service Life

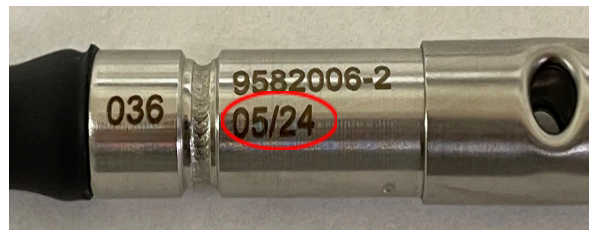
**Identification** :

Vigil Cutter DOM MM/YY

Vigil cutters placed on any Vigil unit should not be older than 6 months prior to the DOM of the Vigil unit.

New or used Vigil AADs with a cutter DOM older than 6 months prior to the DOM of the Vigil unit should not be installed in any parachute rig.

If the age of the cutter exceeds 6 months prior to the DOM of the Vigil unit, the complete Vigil unit should be sent back to the factory for servicing and cutter replacement. For Vigil 2+ AADs, the cutter can be replaced in the field.
